INNOVATIVE SOLUTION FOR STRENGTHENING ORTHOTROPIC DECKS USING UHPFRC: THE ILLZACH BRIDGE

Photo 1: The Illzach bridge

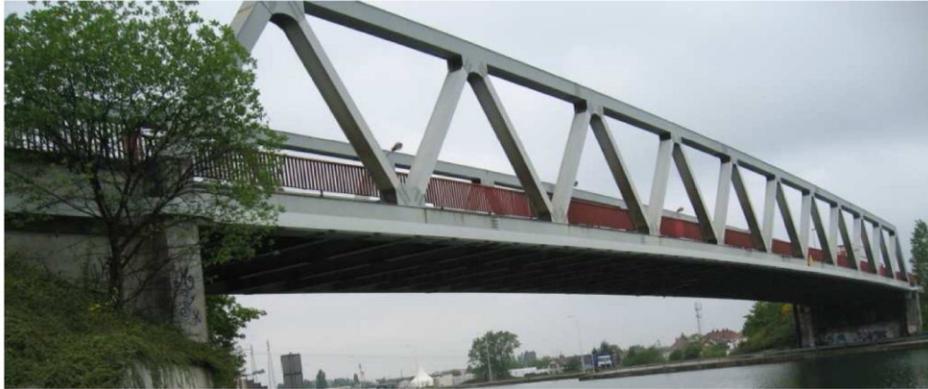
The bridge (Photo 1), which came into service in 1970, is a through-bridge with a single statically determinate span. The 106-m-long Warren girders support an orthotropic deck. The bridge is 12.60 m wide and carries an 8-m-wide 2-lane single carriageway (effective deck width of 11.00 metres).

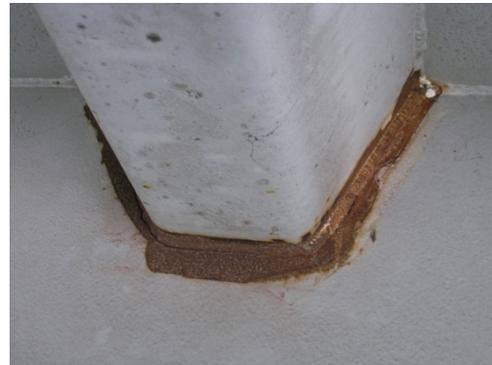
Photo 3: Disorders observed

The 80-mm-thick bridge surfacing laid at the time of construction consisted of a two-course asphalt layer with a coarse bituminous-concrete wearing course. Before it was repaired, the deck had large numbers of cracks along the welds between the troughs and the crossbeams (183 cracks were identified in 2001, with a further 60 being added to the inventory during detailed inspection in the summer of 2009). These cracks were generally located at the bottom of the weld beads, most commonly in the crossbeam web, though some cracks were also in the deck plate. There was no crack propagation, strictly speaking, although four cracks were observed to have extended longitudinally between the trough and the deck plate (Photo 3).

Since water was observed in the troughs, it was feared that there might be fatigue cracks in the deck plate that were not detectable because of the surfacing. A lot of corrosion was also observed on the diagonals of the Warren girders and on the soffit of the deck plate.

The damages observed were chiefly located in the deck, where the trough ribs and crossbeams join, whereas the Warren girders were in a good state of repair. Consequently, the most appropriate repair solution involved local stiffening of the upper deck plate by rigidly connecting it to a thin slab of UHPFRC. Since this appreciably increases the moment of inertia, longitudinal bending forces are filtered by the topping and stresses in the trough-rib-crossbeam welds are considerably reduced. This technical solution was applied with a combination of precasting and in situ keying of the precast parts.

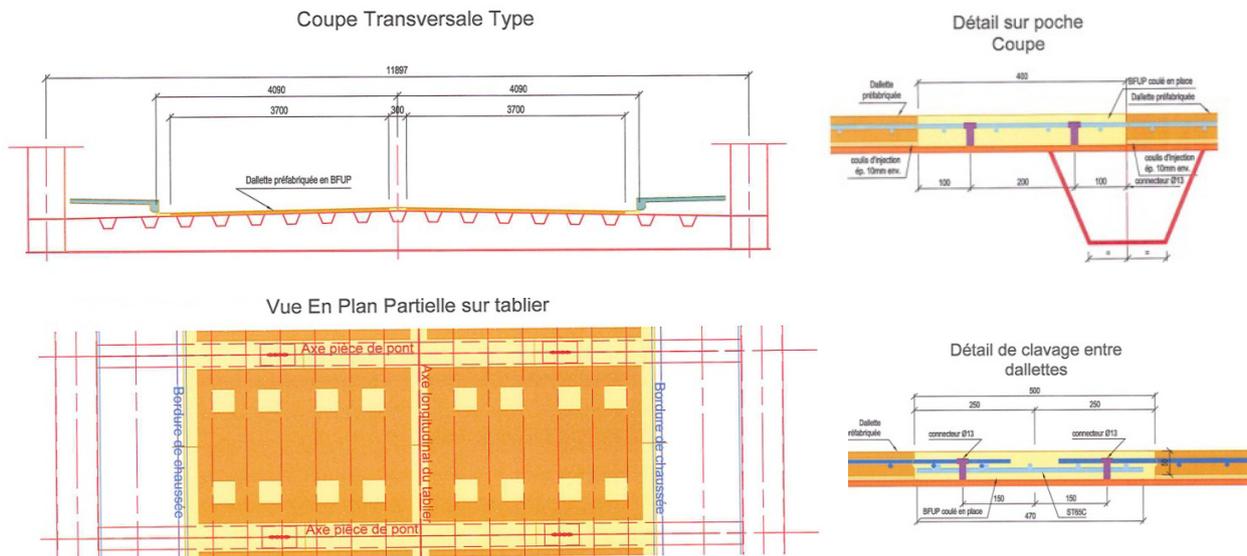
Figure 2: Reinforcement principle

The UHPFRC topping consists chiefly of sixty-six 5-cm-thick precast slabs measuring 3.45 m x 2.70 m. They were placed in two rows lengthways. In addition to these precast units, cast-in-place UHPFRC was placed as three longitudinal keying strips (one 30-cm-wide strip

in the centre and two 20-cm-wide strips at the sides) and as 60-cm-wide transverse strips centred on the crossbeams. Mechanical continuity of the UHPFRC across the keying joints was achieved by an ST 65C welded fabric placed at the level of the neutral plane of the slab. The UHPFRC slab is connected to the deck plate by means of ‘miniature’ Nelson shear studs St37-3K ($\varnothing = 13 \text{ mm}$; $h = 25 \text{ mm}$) in the keying strips and in 380 mm x 380 mm boxouts in the precast units (Figure 2).

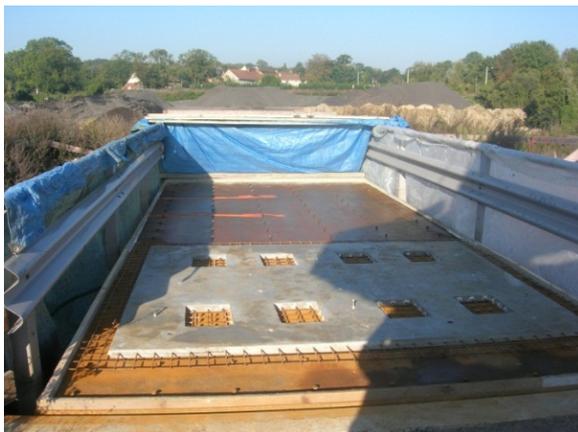
Photo 4: VMD bridge deck – Precast slab

The campaign tested several solutions which could be adopted, depending on the type of project to be carried out under a contract for either construction of a new deck or for repair of a distressed deck. To validate the technical solution adopted for the RD201 bridge in Illzach, a precast UHPFRC slab was connected to the orthotropic steel deck of the VMD bridge (Photos 4 and 5).

The precast concrete slab had boxouts enabling connectors to be concentrated in groups and the slab to be keyed to the steel by means of cast-in-place UHPFRC. This arrangement is similar to that used for composite ladder-deck bridges with precast reinforced-concrete slab decks. The VMD deck was instrumented and loading tests were carried out to quantify the improvements in local and general bending.

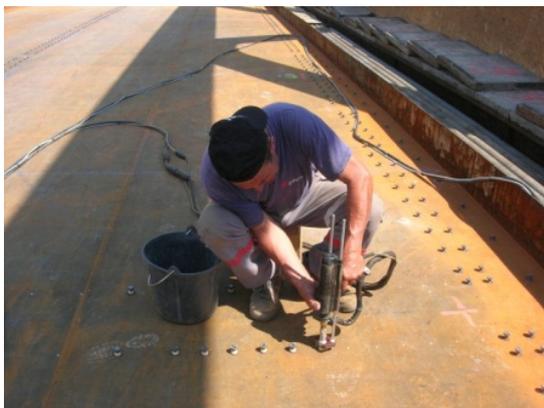
Photo 6: Welding of miniature studs

- drawn-arc welding of shear studs (Photo 6). In all, close to 12,000 studs were welded to the bridge,
- placement and adjustment of precast UHPFRC slabs (Photo 7) using a telehandler, starting mid-span and working to the abutments,
- placement of reinforcement (welded fabric) in transversal and longitudinal keying zones,

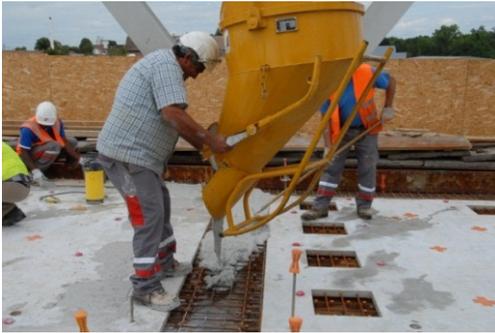
Photo 8: Placement of precast slabs

- in-situ concreting of transverse keying strips and boxouts in the UHPFRC slabs (Photo 8). The BSI® concrete manufactured on-site (same formula as that used for precast slabs) was made with in 250-litre batches using a conventional vertical-shaft mixer,
- grouting of the slab/steel plate interface with a non-shrink mortar. Grouting and venting holes were provided in the precast slabs to ensure proper filling of the interface,
- waterproofing and laying of the surfacing. After preparation of the deck by abrasive blasting, bridging of concrete construction joints, and application of an epoxy-resin primer, a wearing course of gravel and resin was laid to a total thickness of about 10 mm (Photo 9).

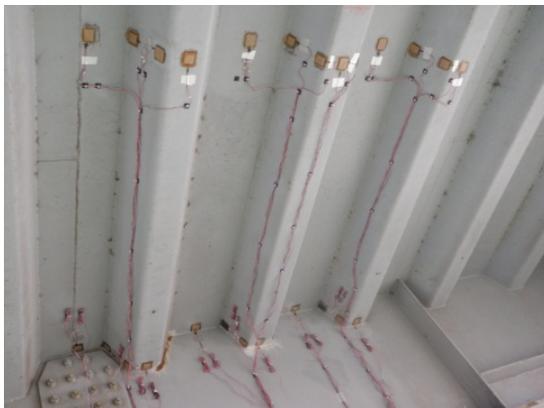
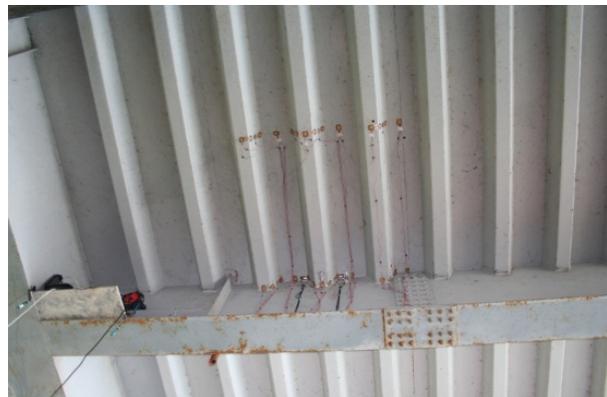
Photo 10: Instrumentation of steel deck plate

- instrumentation of an end zone and of a mid-span zone on a set of three troughs below the wheel tracks of heavy goods vehicles;
- instrumentation of the mid-span section of the main girders with extensometers (top and bottom chords) and with temperature sensors,
- instrumentation of the mid-span section of the mid-span crossbeam with extensometers (top and bottom chords) and with temperature sensors,
- instrumentation of the end zone of the bridge to detect any slippage between the concrete slab and the steel deck plate,
- monitoring of the global deformation of the bridge (mid-span) and local deformation of the mid-span section (bending) of the mid-span crossbeam.

A total of 72 strain gauges were bonded to the bridge soffit and to the main girders (Photo 10). The mid-span section was also surveyed topographically. Reflectors were placed on the top and bottom chords of the main girders. Another was placed on the underside of the bottom flange of crossbeam No. 17, on the bridge centreline. This monitoring served to examine the overall behaviour of the strengthened bridge. Loading tests were carried out before and after strengthening in order to assess the behaviour of the strengthened bridge. Mid-span, the bridge was loaded with 6 trucks, but two were sufficient for the end zones.
