LONG-TERM MATERIAL PERFORMANCE CHECKED ON WORLD'S OLDEST UHPFRC ROAD BRIDGES AT BOURG-LÈS-VALENCE

Overpasses OA4 and OA6 at Bourg-lès-Valence in South-Eastern France are the world's oldest road bridges made of ultra-high performance fibre-reinforced concrete (UHPFRC). They were completed in 2001. From opening to traffic in 2002, no significant maintenance operation has been done. After a decade, the bridges have deserved a detailed survey, deflections were measured and cores were drilled from end transverse zones of one of the bridges spans for long-term performance investigation. Although surface corrosion of the fibres is visible for lower ends of the beams lower flanges, where the surrounding atmosphere is rather humid, fibres are sound in the whole volume of the drilled cylinders, which confirms the high potential durability of the material. Based on characteristics measured on the drilled specimens, the paper details the performance obtained from the tests carried out on the twelve-year old material as compared to the data identified during control of the construction, and concludes on the experience gained.

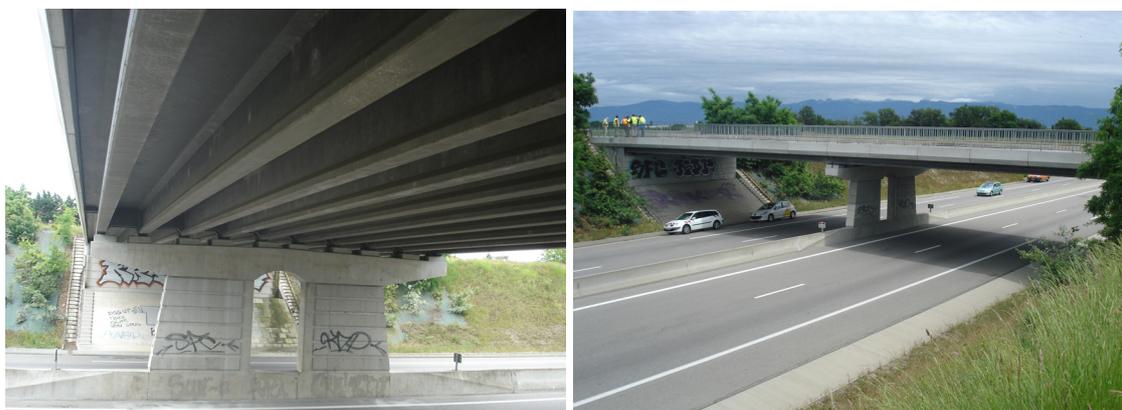
Both bridges exhibit similar visible features after the detailed survey carried out in April 2012, namely 11 years after the structures completion. They are in overall correct condition with no sign of deck damage (Fig. 2). Elegance of a thin crossing over the highway has been visibly kept. Lack of maintenance and non-corrected initial defects have led to local spalling and water-induced current minor damage on abutments made of ordinary concrete (Fig. 3-a). Persistent humidity or condensation in the lower ends of the beam flanges has led to surface visible corrosion of the fibers (Fig. 3-b). However this aesthetical defect is limited and most of UHPFRC facings have kept grey and glossy (Fig. 4). No significant cracks have appeared at cast-in-place UHPFRC joints between the precast beams.

Figure 2: General view of the bridges in operation.

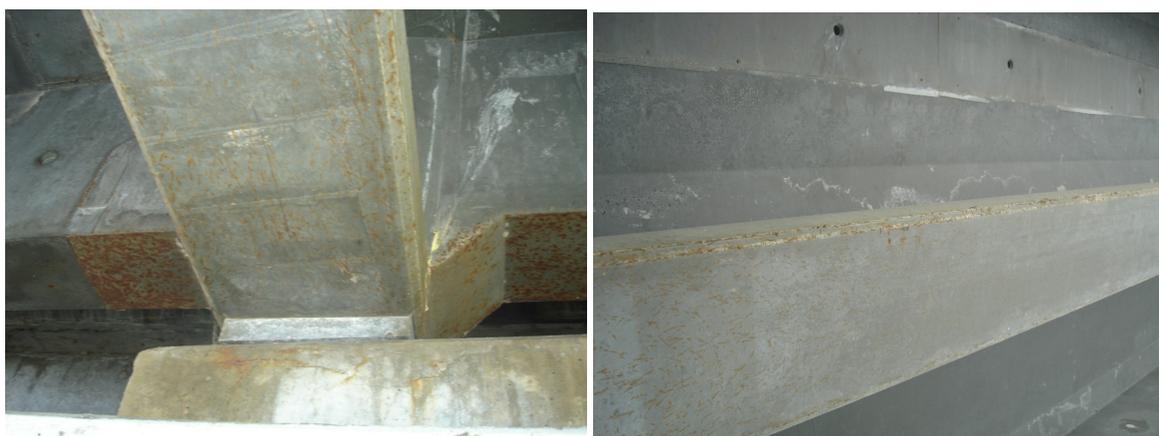
Figure 3: a) Effect of water stagnations over abutments (left)
b) Limited surface corrosion of the fibres at beam edges and end of lower flange (right)

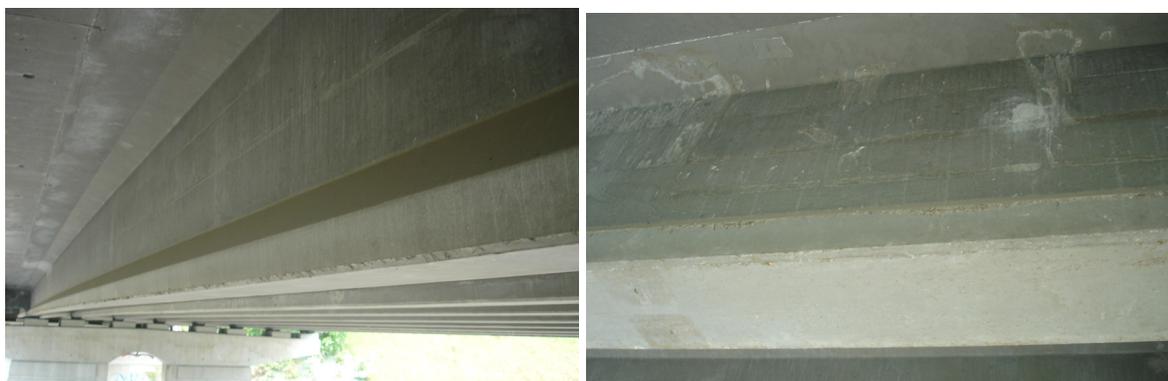
Figure 4: Pi-shaped UHPFRC beams facings

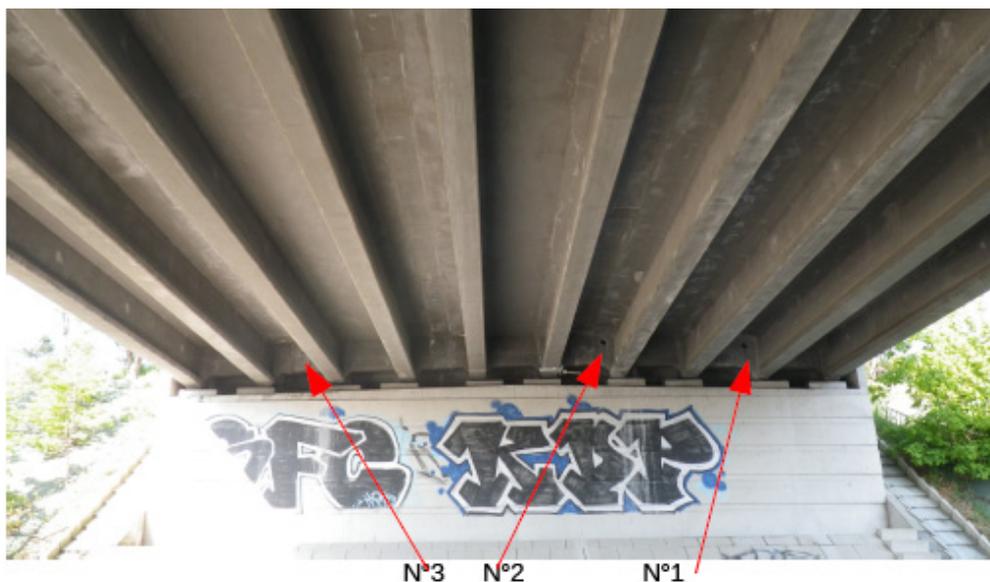
Cylindrical samples about 200 mm long, 94 mm in diameter have thus been drilled in cross-beams of the bridge OA6 at the end of the deck and above the central support (Fig. 5-6). Drilling direction goes from e to s in the symbols used to designate the parts of the samples (Fig. 7-8). All samples had to be dry-sawn at the ends. Moreover, as deviations were observed from the theoretical cylinder shape, samples #2, 4 and 5 had to be over-drilled for being suitable for mechanical testing. Fibers appear as sound (un-corroded) in the whole volume of the drilled cylinders, which confirms the high potential durability of the material.

Figure 5: Cores drilled from OA6 bridge in the cross-beam above abutment

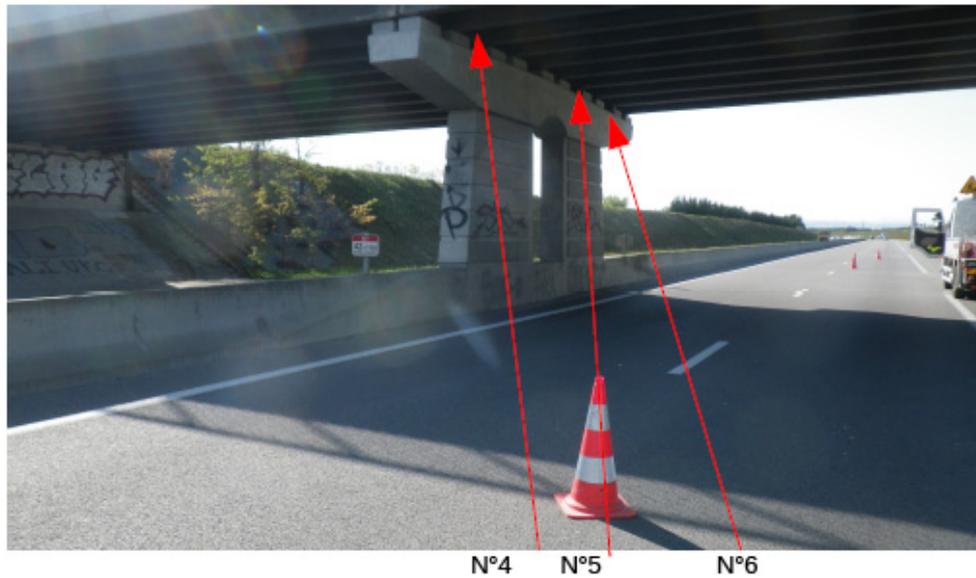
Figure 6: Cores drilled from OA6 bridge over the central support

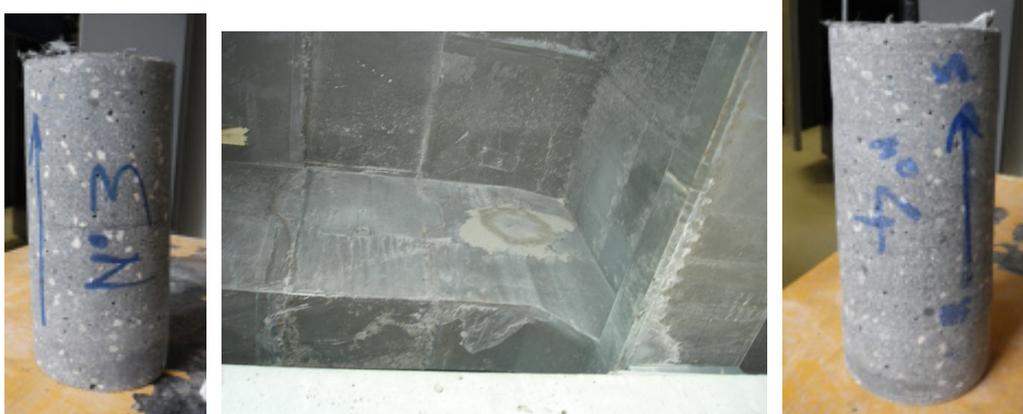
Figure 7: Visual aspects of cores and coring zone. No fibres corrosion.

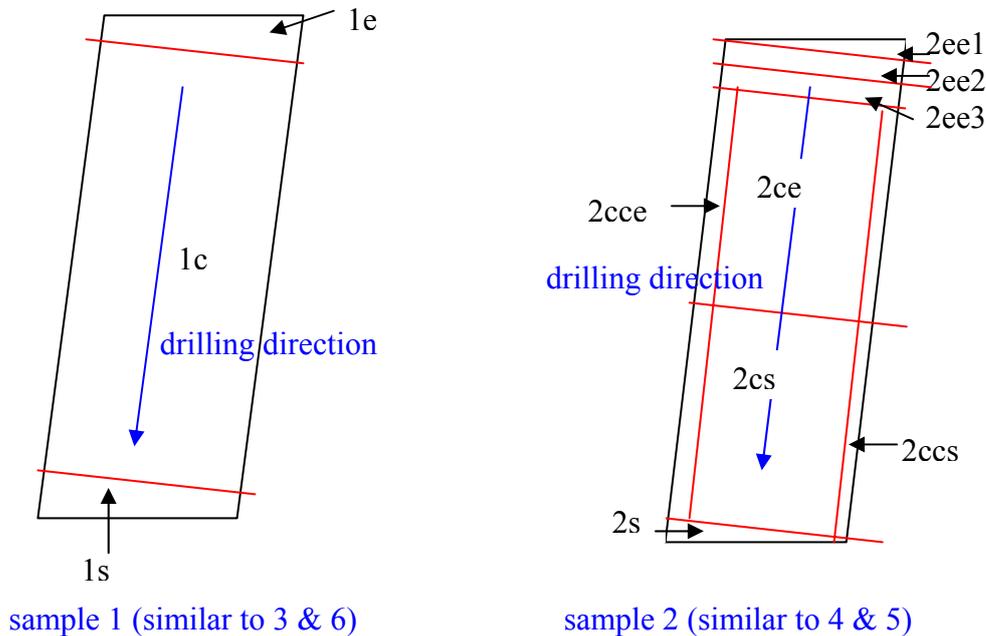
Since cores # 1, 3 and 6 had a regular cylinder shape they were used in compressive tests after sawing the ends for ensuring their axis to be orthogonal to the bases (Fig. 8). The available specimen height is about 150 mm for a diameter close to 94 mm. This aspect ratio tends to avoid end confinement during the tests and associated strength overestimation. The ends were kept for porosity measurement. Cores #2, 4 and 5 have been divided in two parts to get six cylinders with an aspect ratio close to 1, to be preferred for direct tensile tests in a rigid testing setup. Namely, the specimens' diameter was 74 mm and their nominal height 73 mm. The layers sawn from the "e" side of the cores were used for chlorides dosage, in order to identify a possible progression in the content of these aggressive ions. Remaining parts were kept for possible SEM observations or additional control measurements in case of unexpected results. Except dry-sawing of samples 2ee1 to 2ee3 and similar for #4 and #5 cores, other operations used water for cooling the sawing or drilling tools. After preparation, specimens were kept unprotected in the laboratory conditions.

Figure 8: Cores preparation for mechanical, physical and chemical investigations

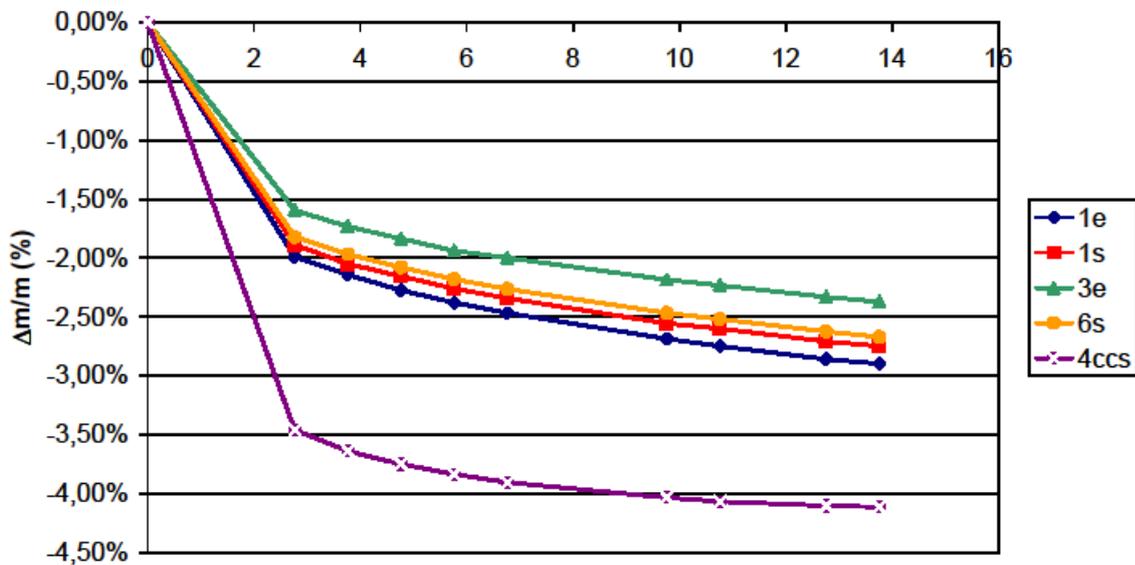
Although specimens had been kept unprotected, the saturation degree is very high, which confirms the very low moisture transfer characteristics of UHPFRC. For the 20 mm disks and even for the tube-shaped specimen 4ccs with only 5 mm-thick walls, drying has remained limited. Mass stability is usually deemed as reached for relative mass variation lower than 0.05 % per day. Conversely to regular concrete, mass stability had not been reached for the UHPFRC specimens following the standard protocol [5]. This is illustrated in Fig. 9. It raises the question of quantitative well-foundedness of standard test protocols to UHPFRC.

Figure 9: UHPFRC samples drying vs. time in days (specimens 20 mm-thick except 4ccs 5mm-thick)

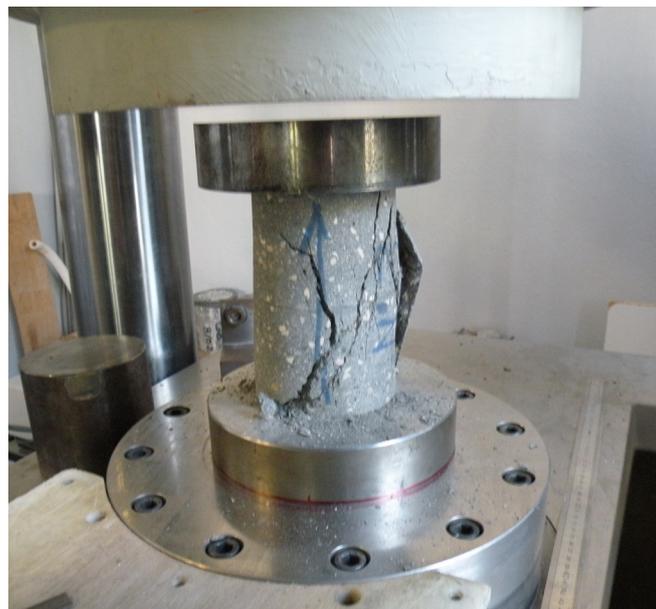
Young's modulus was measured following the LPC protocol [7]. Three compressive loading cycles were applied at a 0.3 kN/s loading rate between 70 kN and 419 kN, corresponding to 5 and 30 % of the estimated compressive strength, respectively. Both longitudinal and transverse strains were measured. After having removed the measuring device, specimens were loaded up to failure (Fig. 10). Results are displayed in Table 3.

After 12 years on-site, the average compressive strength of BSI® is close to 20 % higher than the average 28-days strength generally considered for this material [2]. The cylinders aspect ratio may have had a favourable effect. Their diameter is also somewhat lower than the commonly used cast cylinders, 11 cm in diameter. In the case of cored cylinders, wall effects preventing fibres to be efficient for confinement in the outer part of the cylinder also does not exist (yet even in the present case fibres anchorage in the outer side of the cylinder may also be questioned). These favourable artefacts however hardly explain alone the observed strength increase, which seems also consistent with ongoing slow hydration, already observed for Ductal® after 10 years of age in Cattenom power plant. These results support the safety of AFGC provisions concerning α_{cc} and the UHPFRC design compressive strength [2, 8]

Figure 10: Compressive test, loading up to failure

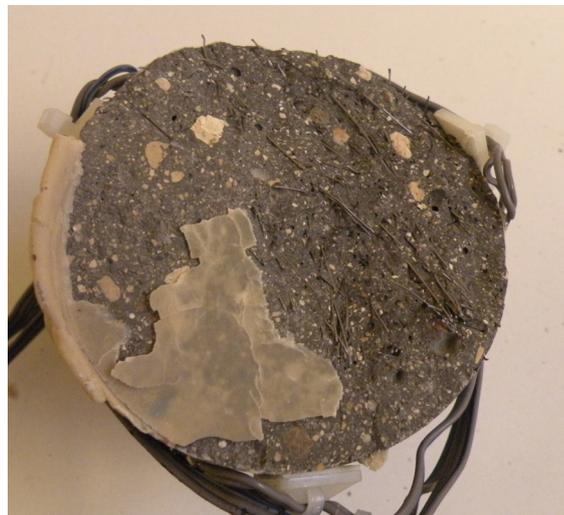
Direct tensile tests were carried out on the six cylinders 2ce, 2cs, 4ce, 4cs, 5ce, 5cs obtained from the drilled samples. Since at least one of the ends was affected by wall effects during casting, and due to insufficiently careful gluing process, the un-notched cylinders all failed partly within the glue joint (Fig. 11), with an average tensile capacity ranging from about 6 to 7 MPa. Due to the non-homogeneous failure surface, a realistic evaluation of the tensile strength of the UHPFRC matrix is impossible. Fibre contribution also cannot be quantified. It has thus been decided to test the specimens again, after grinding once more the end surfaces, creating a notch at mid-height and providing a glue over-thickness to prevent weakness in the end sections where fibres are oriented parallel to the glue joint due to wall effect. Although the matrix limit may be not properly identified, a better estimation of the post-peak tensile response is expected from these further tests, which are currently under preparation.

Figure 11 : Direct tensile test specimen after failure within the glue joint.
